# **Coastal Barrier Breaching, Part 1: Overview of Breaching Processes**

*by Nicholas C. Kraus, Ty V. Wamsley*

1. REPORT DATE <b>MAR 2003</b>		2. REPORT TYPE <b>N/A</b>		3. DATES COVERED <b>-</b>	
4. TITLE AND SUBTITLE <b>Coastal Barrier Breaching, Part 1: Overview of Breaching Processes (ERDC/CHL CHETN-IV-56)</b>				5a. CONTRACT NUMBER	
				5b. GRANT NUMBER	
				5c. PROGRAM ELEMENT NUMBER

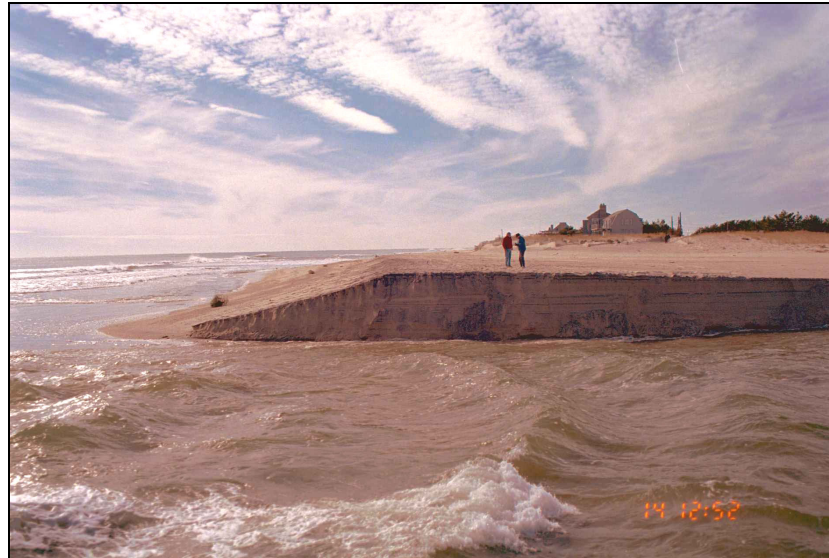
Photographs in Figure 3 were taken several hours after a breach was cut by hydraulic excavator at Mecox Pond, facing the Atlantic Ocean on the south shore of Long Island, NY. Without almost-annual artificial breaching, water level rises in the pond, and basements of bordering residences flood. The breach is left unattended to close under littoral processes, as documented by Smith and Zarillo (1988). Artificial breaching is conducted at several California river entrances such as the Carmel River, Russian River (Rice 1974), and Salinas River for such purposes as improvement of water quality, mitigation of flooding, and opening of migration paths for anadromous fish.

a. Looking east at breach cut through beach berm, Atlantic Ocean to left

Figure 3. Mecox Pond, breached on morning of 14 February 1998  
(photographs taken in afternoon of February 14)

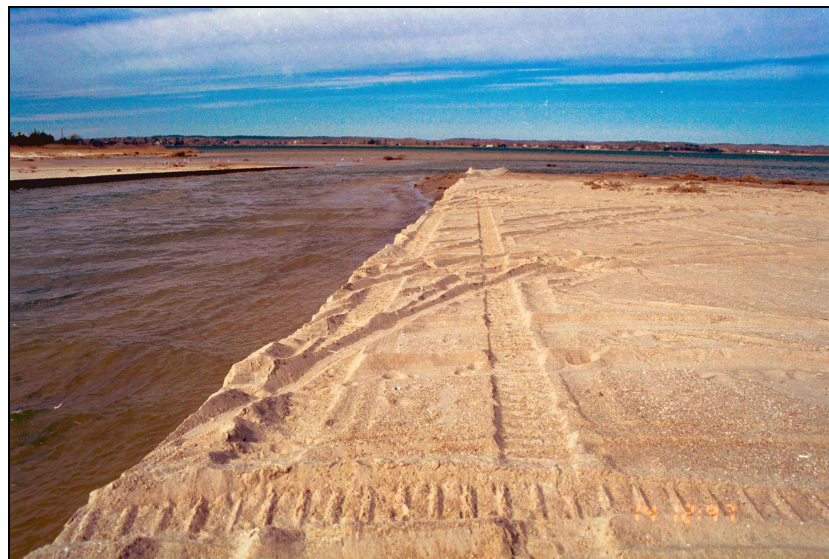
b. Looking north toward Mecox Pond

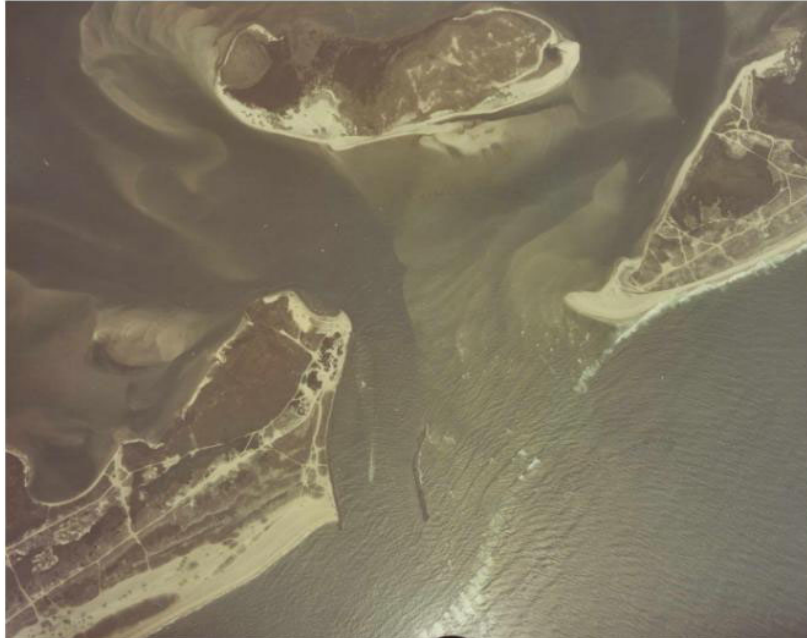
a. 21 September 1980, 9 months after January 1980 breach

Figure 4. Moriches Inlet, NY. Atlantic Ocean at bottom of figures

During 16-18 January 1980, a severe extratropical storm cut the barrier at its narrowest section, and the breach expanded (Figure 4a) from an estimated 91.4-m- (300-ft-) width and 0.61-m- (2-ft-) depth on 16 January to 883.9-m- (2,900-ft-) width and average depth of 3.0 m (10 ft) by October 1980. Moriches Inlet primarily serves shallow-draft recreational vessels, and the New York District monitored the breach without immediate action. Local interests expressed concern about increased exposure to storm-induced flooding in the bay areas and changes in bay salinity on the shellfish industry. The New York District proceeded to close the breach prior to the next storm season. Sorensen and Schmeltz (1982) describe the engineering actions taken. Approximately 1.2 million cu yd of material was required for the breach closure, half obtained from dredging in the back bay and half trucked from a nearby quarry. After closure of the breach, the State of New York and Suffolk County constructed a 487.7-m- (1,600-ft-) long riprap revetment on the bay side of the beach adjacent to the east jetty (Figure 4b). The adjacent beach is part of a county park and popular for bathing and fishing.

**Breach at Moriches Inlet, NY, January 1980.** Moriches Inlet (Figure 4) is one of six federally maintained inlets on the south shore of Long Island, NY, and connects Moriches Bay to the Atlantic Ocean. Inlets to Moriches Bay have been semipermanent and migratory (Sorensen and Schmeltz 1982)<sup>1</sup>. In 1952-1953, rubble-mound jetties 213.4 m (700 ft) apart were constructed “in the dry” at an updrift location, and mechanical cutting of the channel was augmented by a minor storm in September 1953 to open the inlet. The net longshore drift on this coast is predominantly from east to west (right to left in Figure 4). Although the east jetty is on the updrift side of the inlet, the barrier beach narrowed because the strong ebb current directed at and along the easternmost section eroded the shore on the back side of the barrier.

In summary, the breach at Moriches Inlet resulted from narrowing of the barrier island, mainly through erosion on the bay side. Seabergh (2002) describes the processes and possible remedial measures for bayside erosion at inlet entrances. Because the barrier near the east jetty was narrow and low, a severe storm overwashed the weakened barrier, triggering the breach.

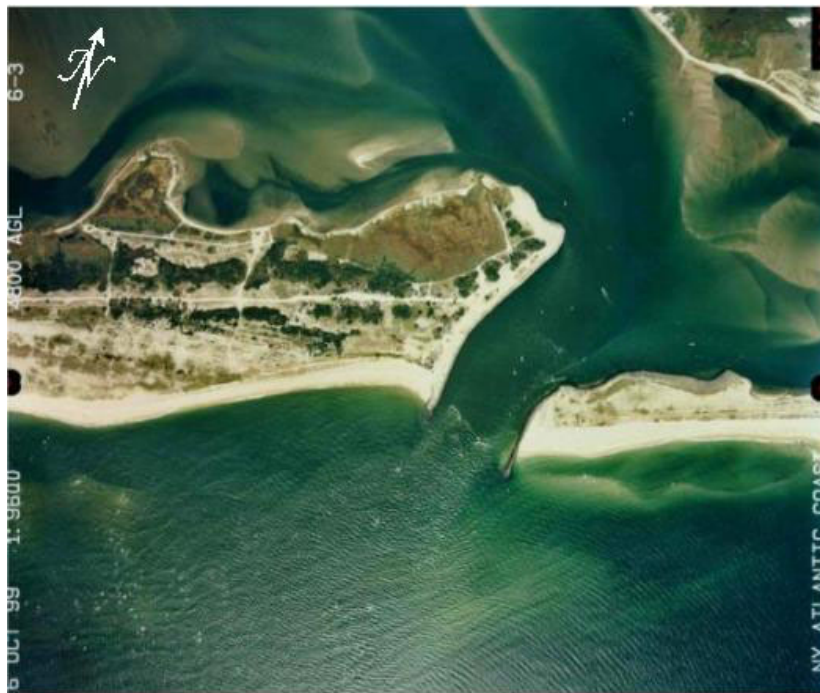
b. 6 October 1999, showing the revetment along eastern bay side

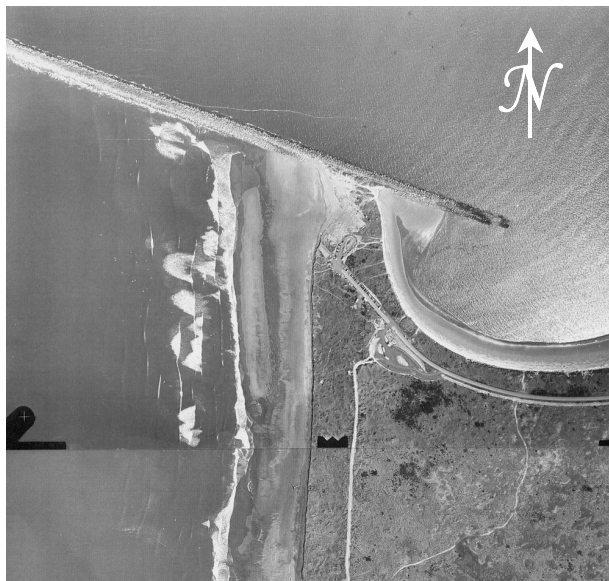
**Breach at Grays Harbor, WA, December 1993.** Grays Harbor is a large bay facing the Pacific Ocean (Figure 5). Two jetties constructed 2.4 km (1.5 miles) apart protect a deep-draft channel and stabilize the entrance. Grays Harbor has one of the largest tidal prisms in the United States. The tidal range exceeds 2 m, and the average annual wave height is greater than 2 m, with deepwater storm waves reaching heights of 8-10 m annually. Large wave heights and long wave periods, typically in the 12-20-sec range, contribute to large setup and runup during storms.

a. May 1993, 7 months before breaching

Figure 5. South jetty, Grays Harbor, WA

At Grays Harbor, the predominant direction of regional longshore transport is from south to north. The beach on the bay side of the south jetty began to erode when the jetty elevation was raised in the mid-1930s. After the south jetty was sand-tightened in the 1970s, the back bay shoreline eroded further, creating what is now called Half Moon Bay (Figure 5a). The south beach gradually narrowed, and a storm on 12 December 1993 breached the barrier spit next to the jetty (Figure 5b). A considerable amount of sand was transported into the Half Moon Bay area by a strongly flood-dominant current flowing through the breach, as compared to the entrance between the jetties, which was ebb dominant. Local interests in the city of Westport, located to the east of the entrance and just behind the breach, grew concerned about loss of land, loss of water wells and increased exposure to waves and currents. There were also concerns that further erosion would threaten the stability of the south jetty and that the eroded material may shoal the entrance channel. The Seattle District closed the breach in the fall of 1994 by placing 600,000 cu yd of sand dredged from the channel.

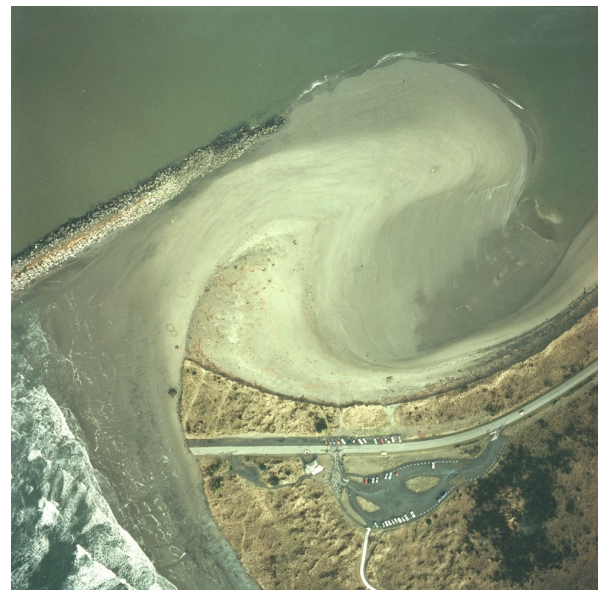
b. February 1994, 1 month after breaching

The barrier spit adjacent to the south jetty has continued to narrow, in particular, by enlargement of Half Moon Bay. The Seattle District constructed an innovative termination rubble mound (Seabergh 2002) at the end of the jetty to align the diffraction and refracted waves more shore normal, reducing longshore transport. A portion of the Half Moon Bay shoreline was also covered with cobble to reduce erosion, and dredged material has been placed in the nearshore of Half Moon Bay by government hopper dredge. A series of storms occurring in the winter of 2001-2002, combined with heavy precipitation that eroded material that had been placed in the breach, raised concern about the possibility of another breach. A technical committee with representatives from the Seattle District, U.S. Army Engineer Research and Development Center's (ERDC's) Coastal and Hydraulics Laboratory (CHL), local consultants, and local officials was formed to inspect the site and make recommendations. It was concluded that the jetty termination mound, existing berm, and shore-protection measures had performed as intended, and that the berm should be raised to the elevation of the natural beach along the coast. This was done, together with planting of dune grass to retain the placed sand (Arden, in preparation).

In summary, breaching at Grays Harbor during a storm in December 1993 was caused by a narrowed and lowered barrier spit. The beach had eroded both from the bay side and the ocean side. Placement of an adequate volume of sand in the breach and cobble on the bay side shoreline to reduce erosion proved effective under multiple storms. The lessons learned was that heavy precipitation could create gullies and weaken the berm fill. Therefore, planting of vegetation on the berm was considered a means for holding sand and collecting additional wind-blown sand to maintain or increase beach and dune volume.

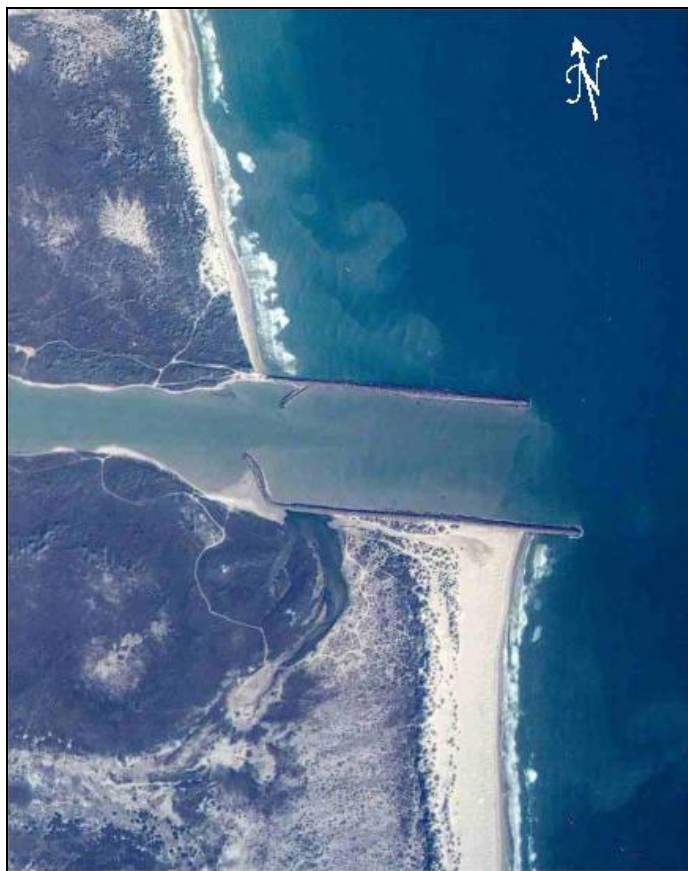
**Mansfield Pass, TX.** Mansfield Pass is an inlet located along the southern coast of Texas. Breaching potential exists at both the north and south jetties. As seen in Figure 6, the net direction of transport is strongly to the north. Formerly a harbor of refuge, Mansfield Pass presently provides access for shallow-draft recreational vessels and small commercial fishing boats. Maintenance dredging has decreased, and material dredged from the channel is placed on the beach of the Padre Island National Seashore adjacent to the north jetty. Insufficient volume of dredged material has

Figure 6. Mansfield Pass, TX, December 2001

The Galveston District has also noted a runnel (small channel) located along the beach next to the south jetty, apparent as a narrow strip of white sand cutting through the vegetation line in Figure 6. The runnel is probably created by surge and waves piling up water at the jetty during storms, as well as by runoff from the beach during heavy rain. This problem is remedied by dune rehabilitation and re-routing and dispersion of water pathways.

required the Galveston District to consider fail-safe alternatives to prevent a breach along the north beach, adjacent to the north jetty. The alternatives include (a) a geotube or a stone revetment buried in the dune to be unobtrusive unless uncovered, (b) landward extension of the jetty, (c) placement of beach-quality material available from nearby disposal sites landward of the north jetty, and (d) combinations of (a) to (c).

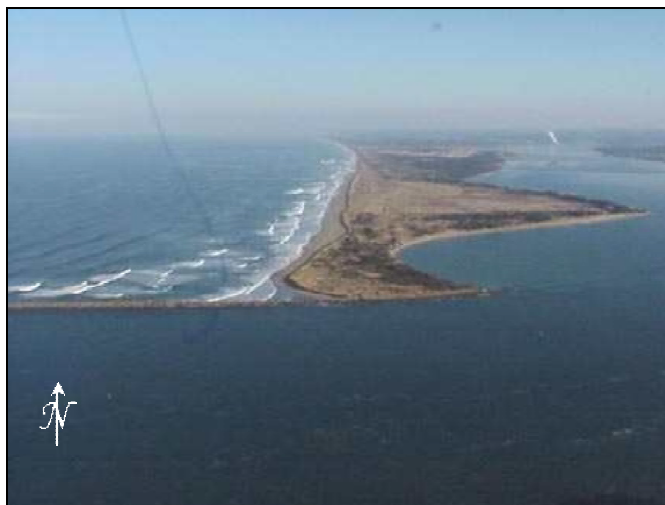
**Coos Bay, OR.** The north jetty at Coos Bay (Figure 7a) was constructed during 1892-1894, including a substantial effort at stabilizing the beach and sand dunes of the north spit. The 1998-1999 storm season resulted in significant shoreline recession adjacent to the north jetty. Approximately 103.6 m (340 ft) (35 percent) of the beach width was lost. In addition, a runnel or hydraulic flow path was established adjacent to the north jetty, the focusing effects of which are evident in the accelerated shoreline erosion of the vegetation line shown in Figure 7b. The combination of beach width loss and runnel creation made the back section of the jetty vulnerable to

a. View of north jetty and barrier spit, looking north

Figure 7. North jetty, Coos Bay, OR (December 2002)

overtopping; this section of jetty had a crest elevation that was 2.7 m (9 ft) lower than the seaward section. The more than 100-year-old jetty was subsequently severely damaged during a severe Pacific Ocean storm in November 2002 that removed stone near its connection to the beach (Figure 7b). The opening was approximately 30.5 m (100 ft) wide (Figure 7b), and the repair section is 152.4 m (500 ft) long. Repairs were accomplished from December 2002 (Figure 7c) to January 2003 as an emergency action. The lower crest elevation near to the shore prevents sand accumulation or impoundment at the jetty, narrowing the barrier, and increases the potential for a breach to open next to the jetty. In addition, wave energy from the channel side has increased with wider and deeper navigation channels, allowing significant wave attack from the channel side. Although this particular breach occurred in the jetty itself, there is also concern about breaching through the coastal dune into the inner embayment seen in Figure 7a.

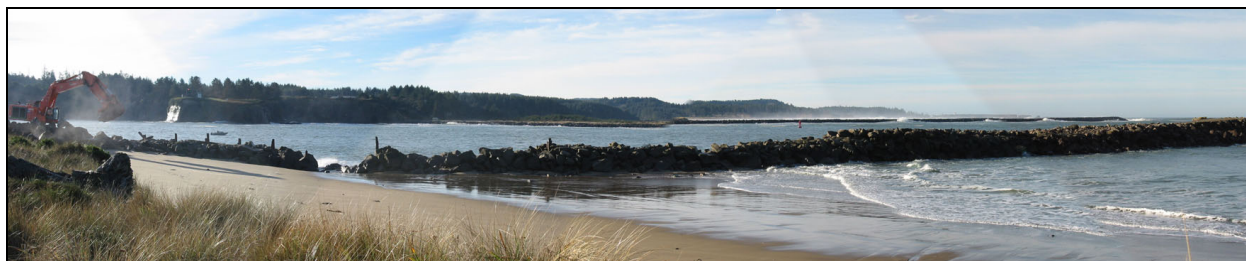
c. Panorama of jetty under repair
